In Situ Corrosion and Heat Loss Assessment of Two Nonstandard Underground Heat Distribution System Piping Designs

Final Report on Project F07-AR01

June 2011

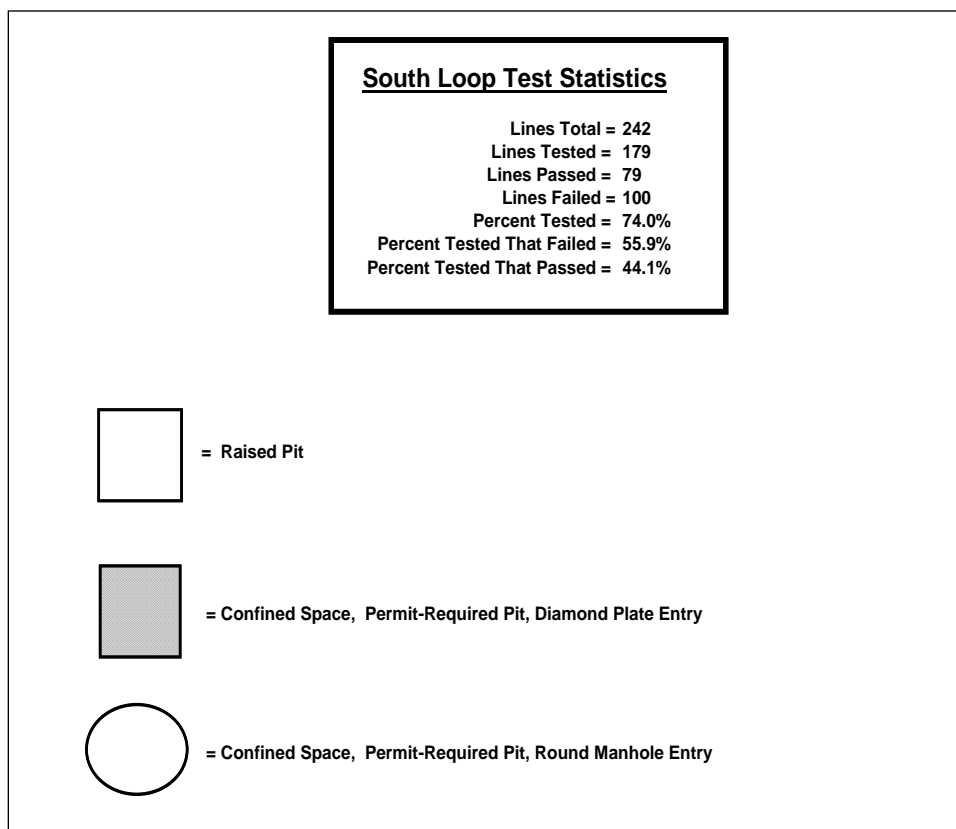
Figure 9 summarizes the test results for the South Loop, indicating a failure rate of 55.9%. It also provides a legend for structures shown in Figure 10, the South Loop schematic diagrams. (Note that Figure 10 extends across five pages.) Detailed test results for each valve pit and conduit segment test data are provided in Appendix I.

Figure 9. Fort Carson South Loop pressure test summary and legend for Figure 10.

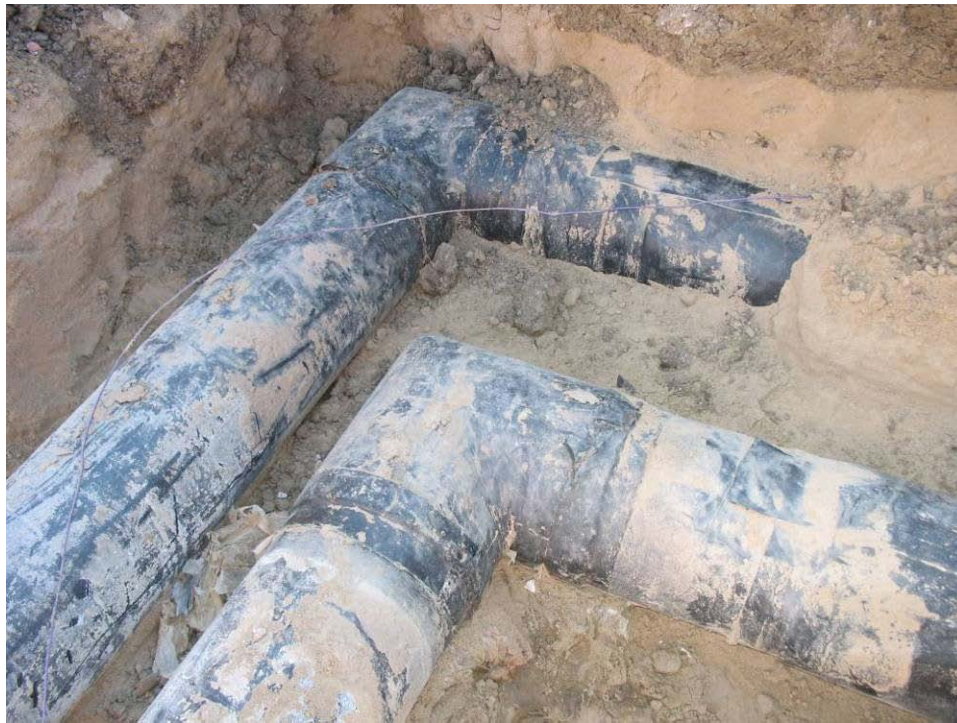
5. Damage Observation (Abrasion, wear, damage, workmanship): No significant damage, wear or abrasion; construction workmanship is good.
6. Nature of "Select Backfill": Pea gravel and native earth used for backfill after system installation.
7. Inclusions, if any: Small-medium rocks, occasional construction debris
8. Depth of Burial: 42" below grade to conduit top.
9. Conduit Separation: 15" (east-west run), 20" (north-south run) center-line to centerline
10. Native soil type at burial depth (@ ASHRAE Site 6):
 - a. Sandy Lean Clay
 - b. Grain: Fine-Coarse
 - c. Consistency: Very Stiff
 - d. Moisture: Low-Moderate
 - e. Clay: Moderate-High
 - f. Plasticity: Moderate
 - g. Color: Brown
11. Soil Resistivity at burial depth: 2,000. ohms/cm²
12. Photo Documentation: See Figure 29 and Figure 30.
13. Any other data that would influence the system: N/A. Elbow inspection site.

Figure 30. Site 6 excavation, detail of conduit and elbow.

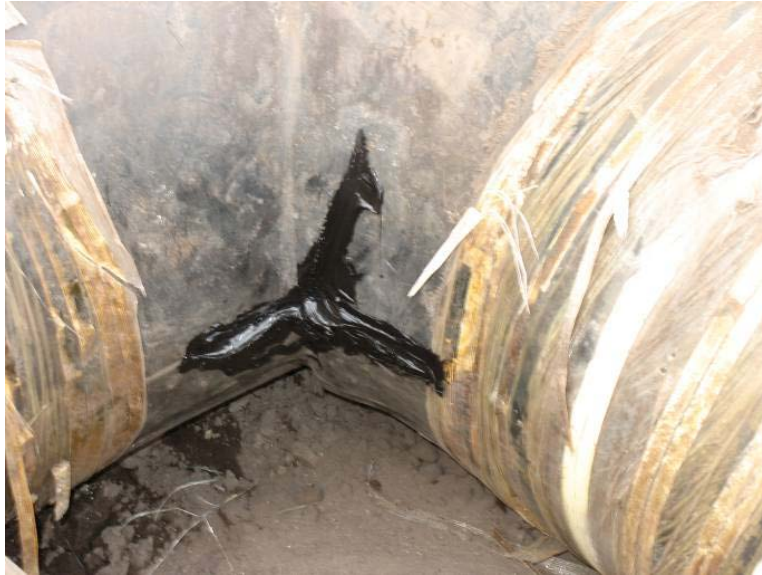
- outer elbow thermocouple location shown in Figure 42 — 112 °F
- inner elbow thermocouple location shown in Figure 43 — 88 °F.

Figure 43. Jacket defect repair showing black silicone sealant.
